Performing a Reliability Assessment Deferred \$50 Million in Capital Costs

David Bereskin, PE¹, Dennis Porter¹, J.D. Solomon, PE, CRE, CMRP²

¹ Greenville Water System

² CH2M

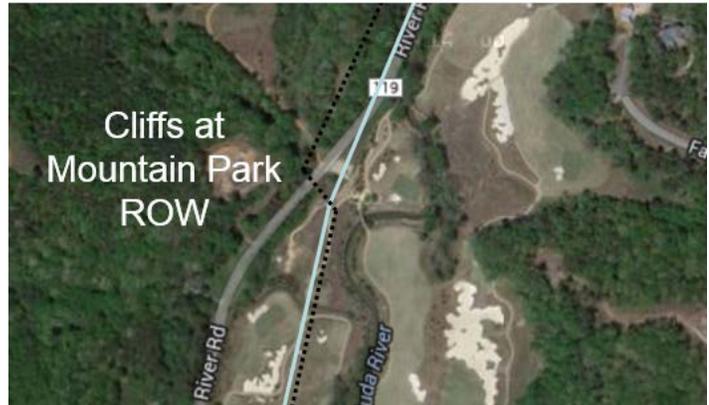
Transmission main route along the Cliffs at Mountain Park – the transmission main is located through the golf course. While GW has ROW through the property and has maintained good communication with the owner, this area may require special considerations for access.

This range of failures provides a good reason for the development of a repair/mitigation plan for this transmission main. While staff has experience in working with PCCP and feel they can repair a leak within approximately 5 days, there may be some areas that are difficult to access or may require additional coordination with the property owner or South Carolina Department of Transportation (SC DOT). CH2M HILL has identified the most critical areas for excavation along the transmission main route. These areas include:

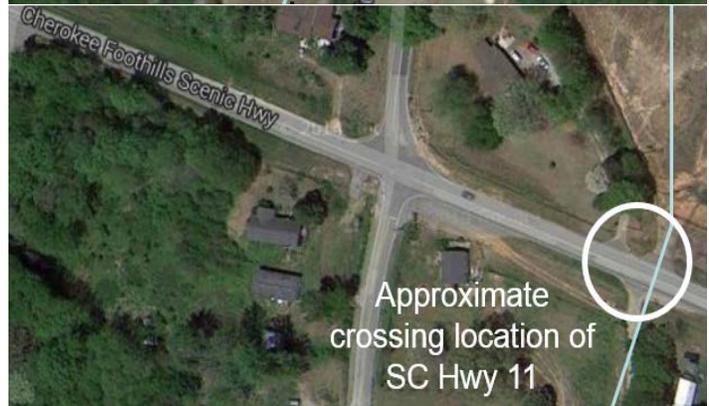
Crossing of SC Highway 11 - activities for road improvements were being constructed during the time of this study. This is a highly traveled area that will require coordination with the SC DOT.

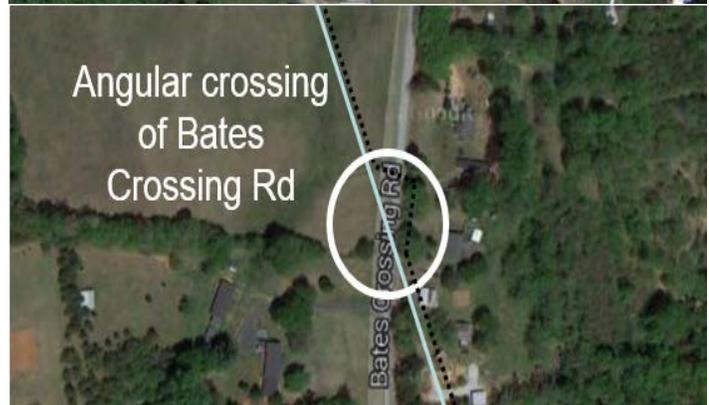
Side road crossings (Hart Cut Road, Bates Crossing Road, Pleasant Retreat Road) – repair procedures may be extensive due to the angle of the road crossings in these areas. Mitigation plans should include communication with nearby property owners in these areas for an extended road closings.

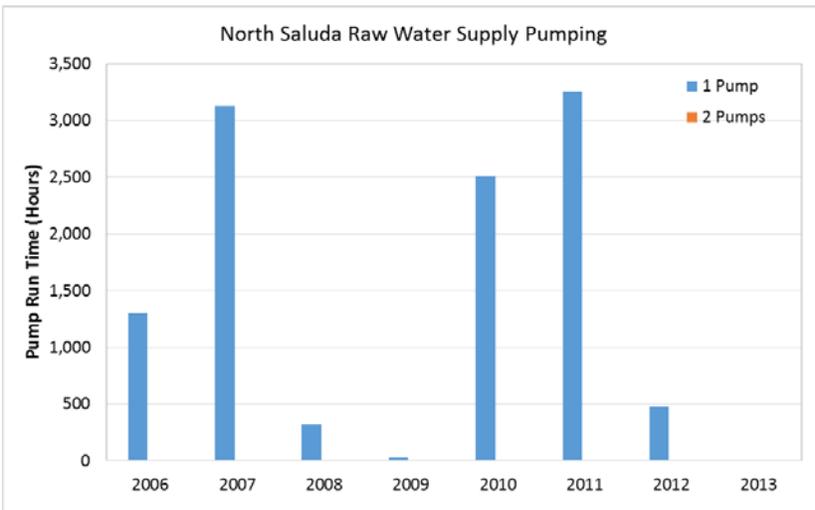
Figure 3

Pumping Hours Since 2006 (Cumulative All Pumps)

Since most of the flow has historically been obtained by gravity, the NS RWPS has low operating hours (Pump #1 has 7,904 hours, #2 has 8,201 hours and #3 has 8,053 hours of recorded service). These pumps have never been rebuilt, nor have they had any major modifications to the interior of the pumps.
