Performing a Reliability Assessment Deferred \$50 Million in Capital Costs

David Bereskin, PE¹, Dennis Porter¹, J.D. Solomon, PE, CRE, CMRP²

¹ Greenville Water System

² CH2M

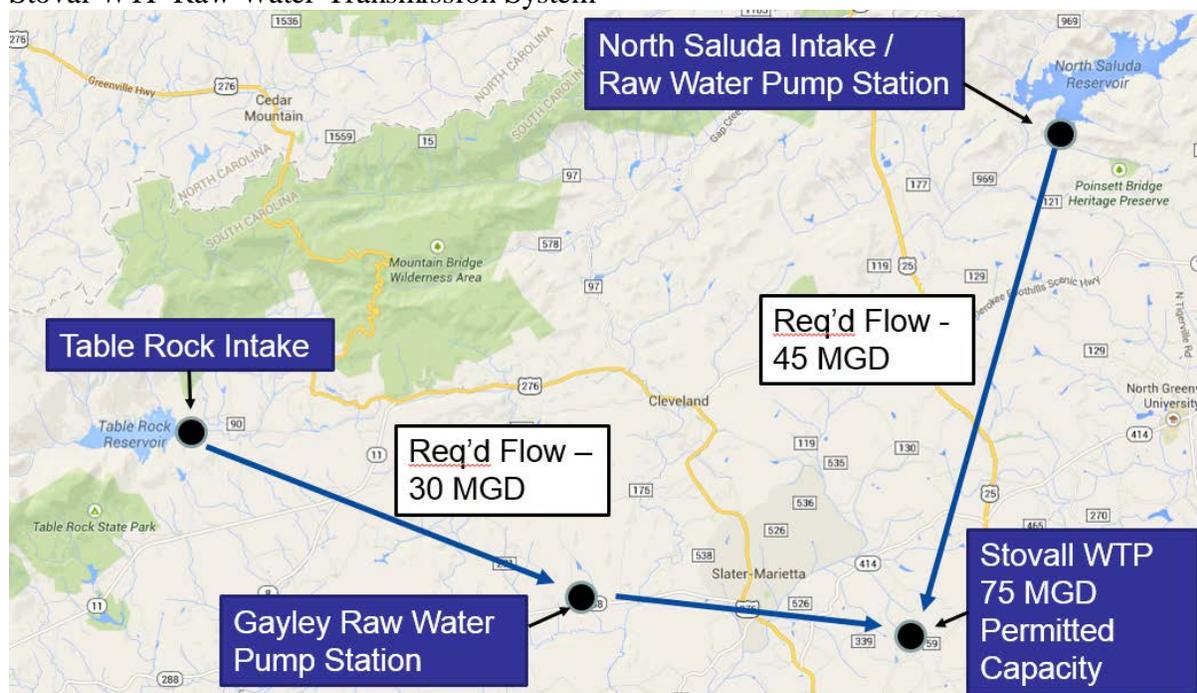
Figure 1
Stovall WTP Raw Water Transmission System

Based on workshop discussions, it was determined that the primary intended function of the raw water transmission system was to provide 75 mgd of raw water to the Stovall WTP, 30 mgd from the Table Rock subsystem and 45 mgd from the North Saluda subsystem. The location and general description of the required flows from each subsystem is shown in Figure 1.

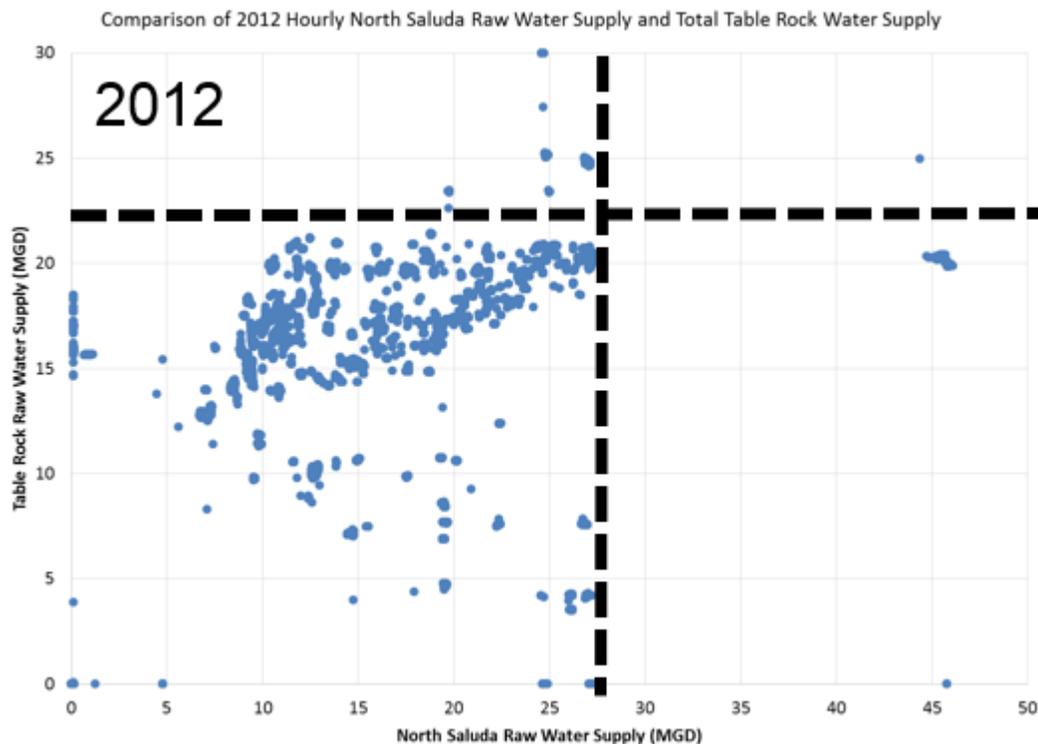
Figure 2

Scatterplot of 2012 Hourly Flow Data for North Saluda and Table Rock Water Supply

The lower left quadrant of Figure 2, as defined by the black dashed lines, indicates the hours when gravity flow was typically received at the Stovall WTP. While there are few points outside of this quadrant flow for 2012, the data points confirm that the Gayley RWPS is typically used before the NS RWPS. This data also shows no points above 45 mgd for NS RWPS, which indicates no usage of more than one pump at a time. This data was additionally correlated to annual and seasonal weather patterns to help validate the impacts of seasonal variations on water demand.

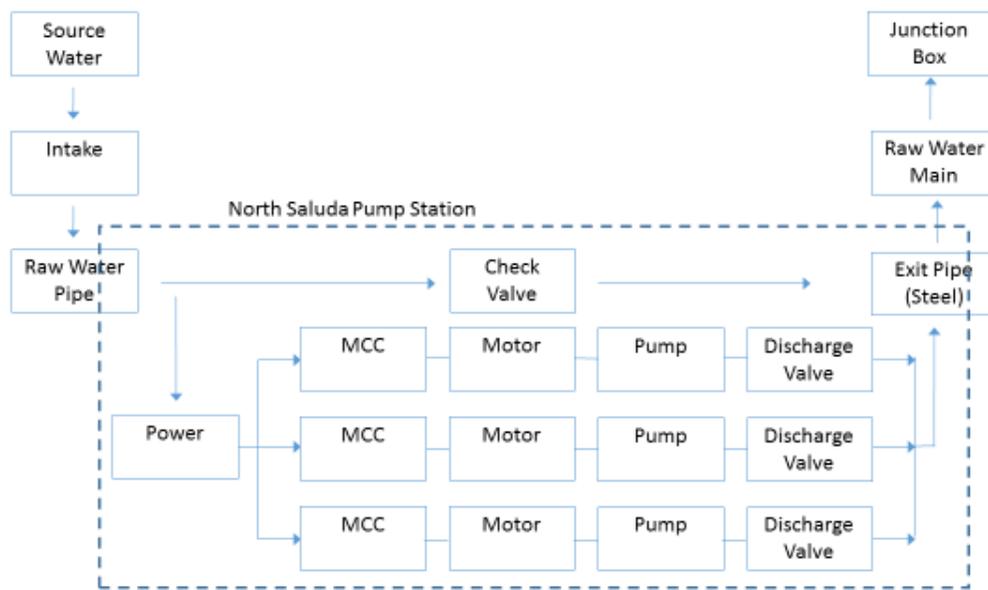
Figure 4

Failure modeling was performed using a combination of Fault Tree Analysis (FTA) and Reliability Block Diagram (RBD) analysis. With the assistance of GW, a schematic layout of the North Saluda subsystem was developed as shown in Figure 4, where each block is a critical point in the subsystem and each of the three pump systems is represented by the second block diagram. The BlockSim module within the Reliasoft reliability software suite was used to facilitate the reliability calculations. Reliability parameters were based on published references and modified, where applicable, based on site related information and experience.

Workshop Schematic of North Saluda Subsystem RBD
